Manhole Inspection Summary

Manhole # S37A__021MH

Inspection ☐ Is Incomplete Rating: **3) Fair**

Location Address: **rear 411 the fallsway**

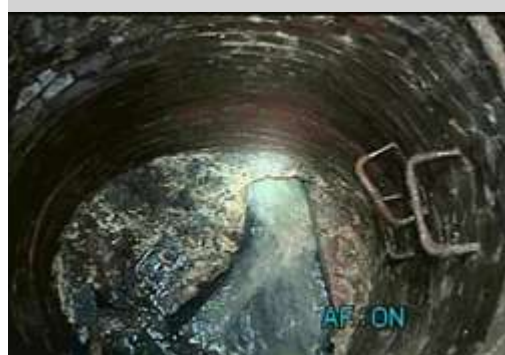
Top View

only two pipes at bottom the channel makes a turn

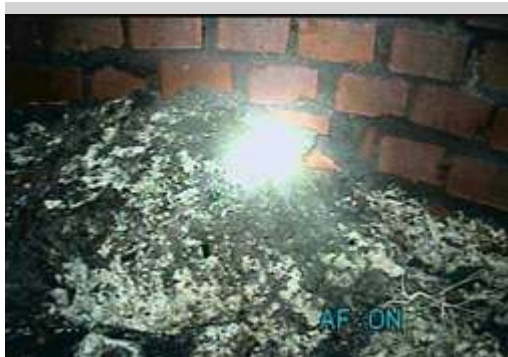
Defect 3

Condition: ☐ Sound ☐ Cracked ☐ Root Intrusion ☐ Deteriorated ☐ Leaks ☒ **Debris**

bench debris

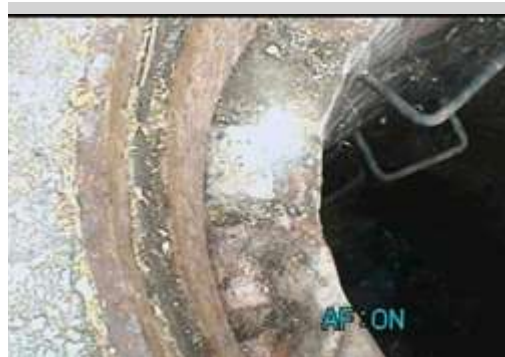
Defect 2

Frame Offset: **5** (in.) Condition: ☒ Sound ☐ Cracked ☐ Leaks

offset

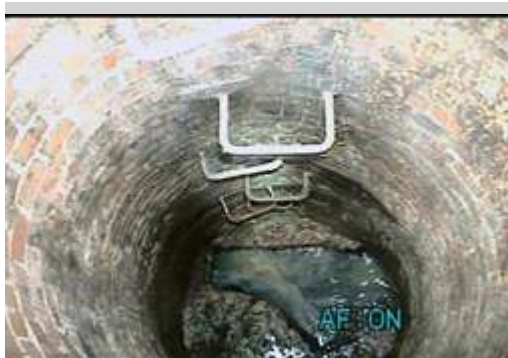
Defect 1

Steps Count: **6** Missing: **0** ☒ **Corroded**

cor. steps

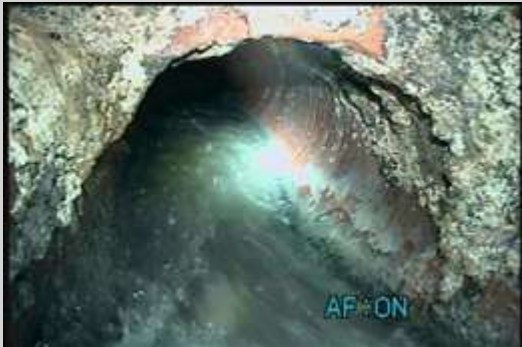
12 O'Clock Outflow

15 in. Circular Gravity Sewer
Pipe Out @ 12 O'Clock

Invert Depth: **12.00** (ft.) Flow Characteristics: **Fast**

Infiltration: **None** Pipe Seal Cond: **Unknown**

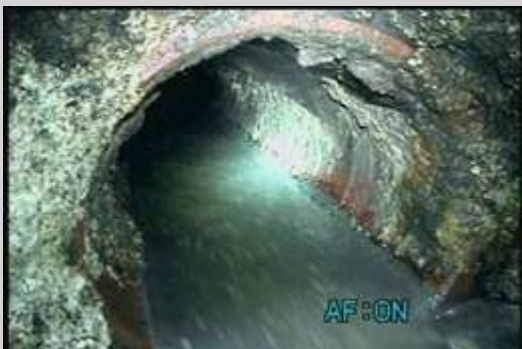
4 O'Clock Inflow

15 in. Circular Gravity Sewer
Pipe In @ 4 O'Clock

Invert Depth: **11.41** (ft.) Flow Characteristics: **Fast**

Infiltration: **None** Pipe Seal Cond: **Unknown**

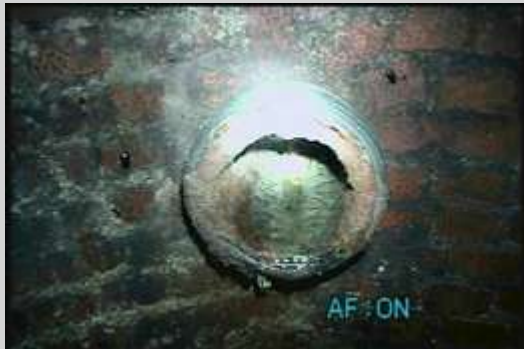
7 O'Clock Inflow

6 in. Circular Gravity Sewer
Pipe In @ 7 O'Clock

Invert Depth: **7.50** (ft.) Flow Characteristics: **Slow**

Infiltration: **None**
